ELEVATOR REPAIR REPORT

October 25, 2024

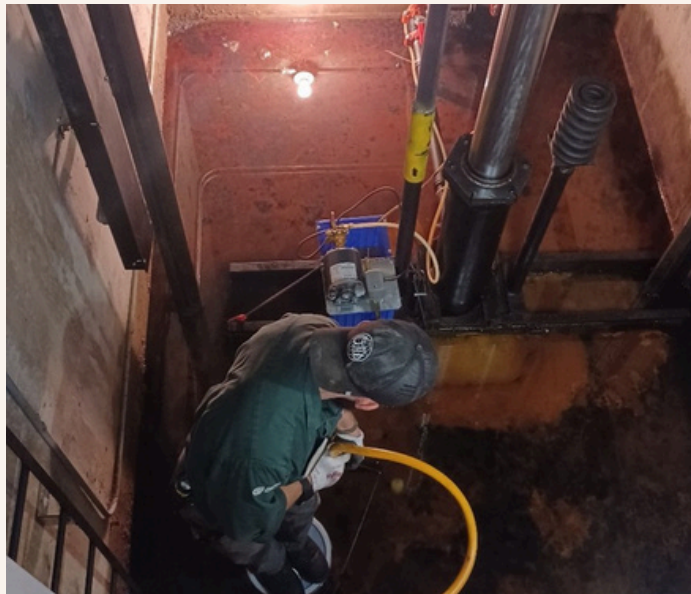
Cleaning the elevator pit during the jack leak diagnosis stage

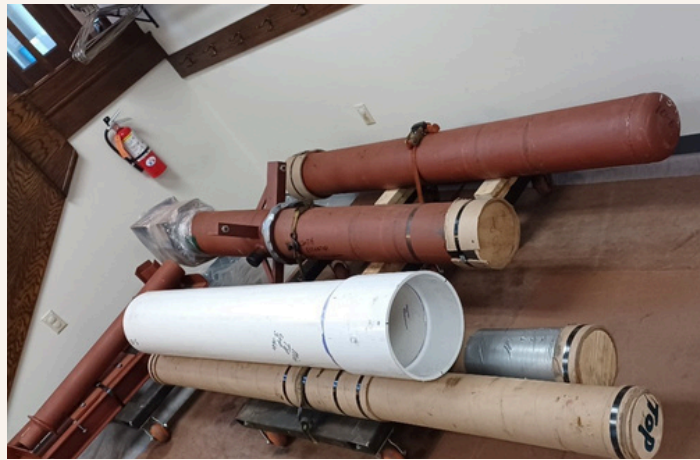
New jack parts awaiting installation

This past January, MEI received the new elevator jack. They removed the old jack and installed the new one. The new jack is enclosed in a plastic pipe to protect it from the ground to keep it dry and prevent corrosion. Large stones were discovered near the bottom of the hole, possibly from an old stream bed, preventing the tube from being installed. This could have been an expensive problem if the hole needed to be redrilled. The vacuum truck company that was removing water and debris from the hole came to our rescue. The next day they returned with an industrial high pressure water jet that they used to slice pieces off the rocks to enlarge the hole at a fraction of the cost of drilling!

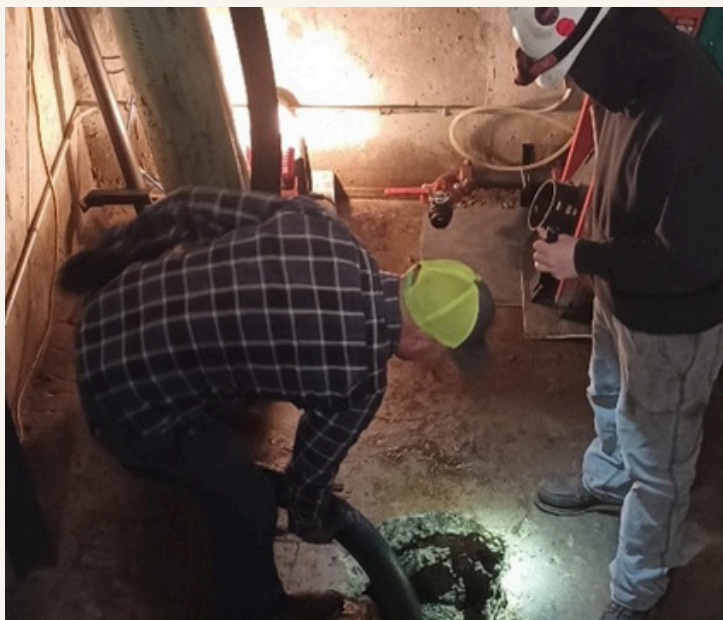
Vacuuming debris from the jack hole

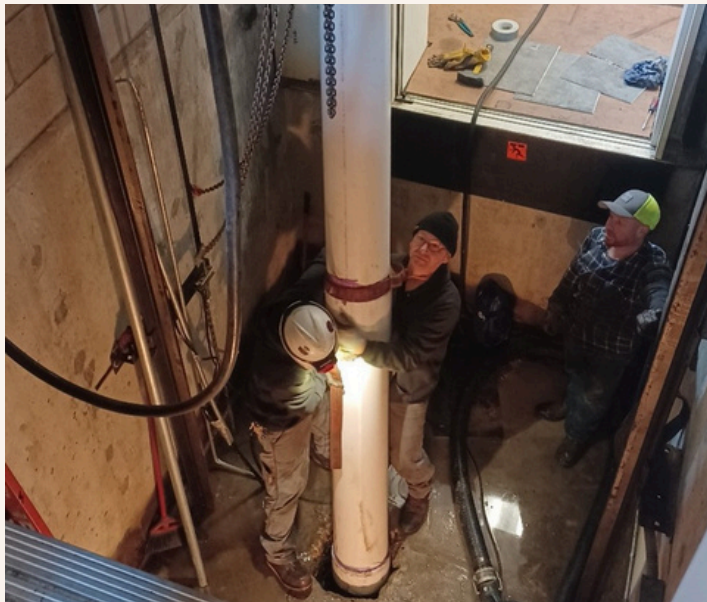
Attempting to install the plastic pipe jack liner

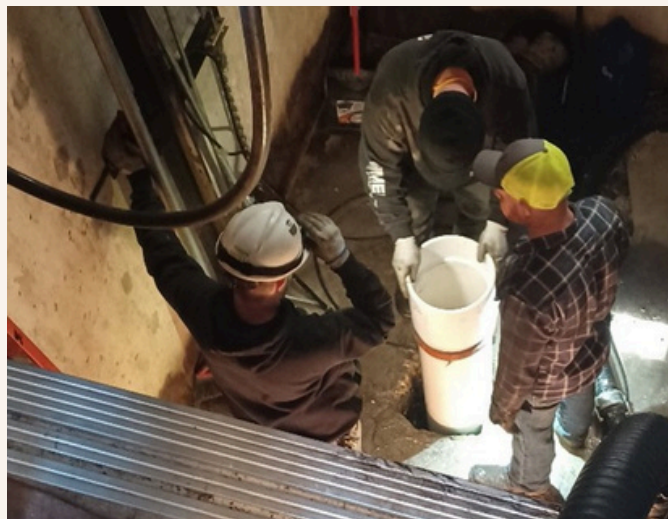
Rock and stones discovered at the bottom, block the new liner from being positioned fully at the bottom (within three feet of jack hole)

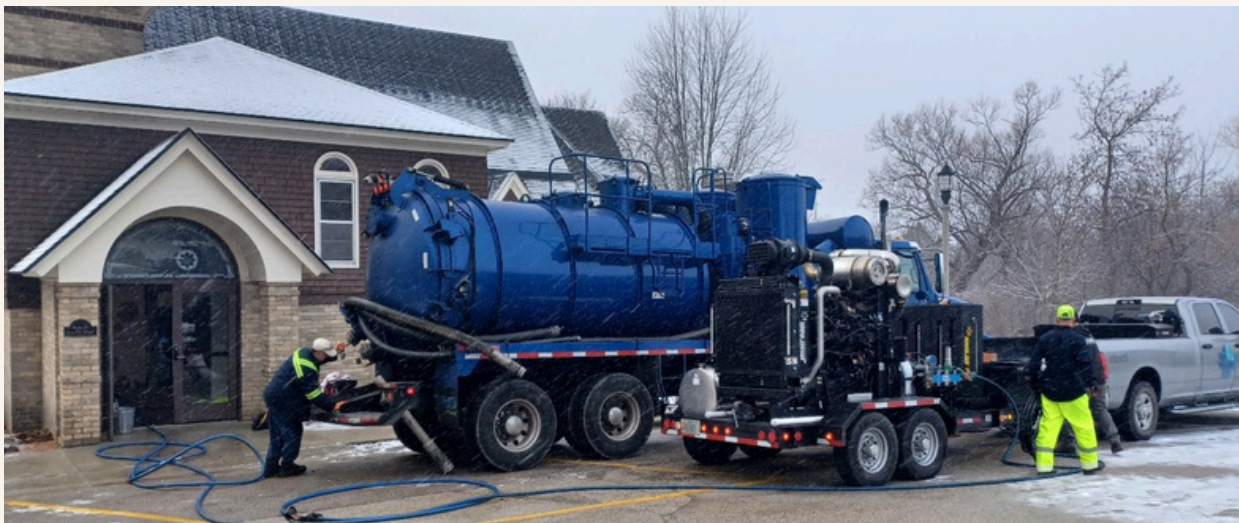
The blue 'Super Sucker' vacuum truck (in background) and the high-pressure water jet diesel pump trailer (in foreground)
